Blue Haze Leachate Treatment Plant

Blue Haze LTP Case Study

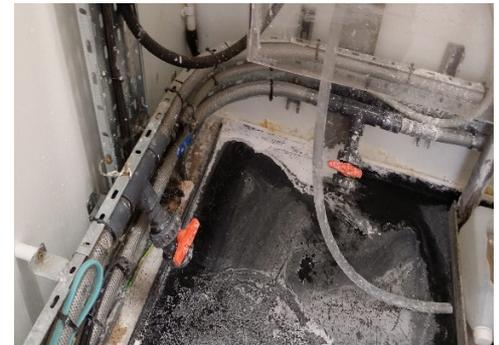
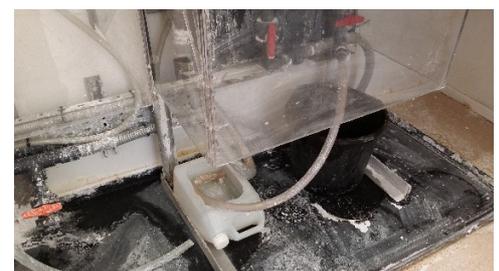
CHEMICAL DOSING

The existing chemical dosing plant was in a poor state with many leaks and corroded components. The original design had also allowed for undersized dosing pumps which meant the pH level in the SBR was difficult to maintain and resulted in the pumps running most of the aeration cycle. Phoenix replaced the whole system within the dosing room with new larger capacity pumps and all new pipe lines and valves. Temperature sensors were added to the dosing lines to monitor the delivery system pipe temperature.

The Sodium Hydroxide dosing system was replaced. The original having sprung many leaks and the dosing rate to the SBR was below that required to stabilize the pH level.
